LAKE SHORE EROSION

WYNDHAM J. ROBERTS

State Water Survey, Urbana, Illinois 61801

ABSTRACT.—Erosion of lake shores by boat traffic is a serious problem which needs to be given more attention. This erosion contributes to the filling in of reservoirs. A gabion wall is recommended.

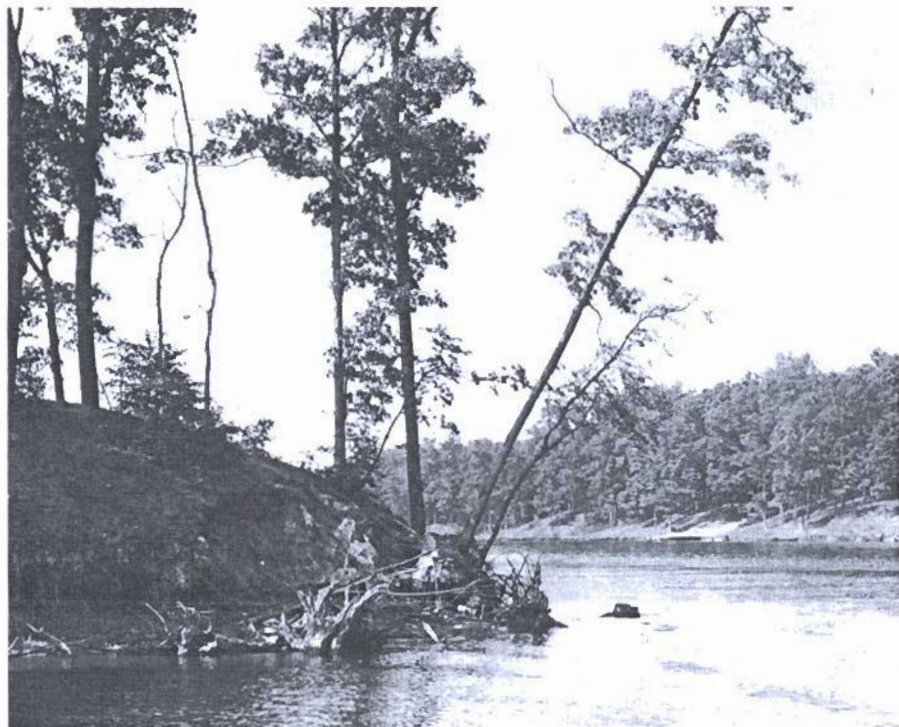
Although most of the deposited sediment has been transported from the total watershed, a portion consists of material eroded from headlands in the lake that have been under attack of wave-generated winds and ice pressure, like the slope shown in Figure 1. When sufficient sediment is eroded to make a protective beach, the rate of headland erosion is greatly reduced.

FIGURE 1. Lake headland eroded by wave action.

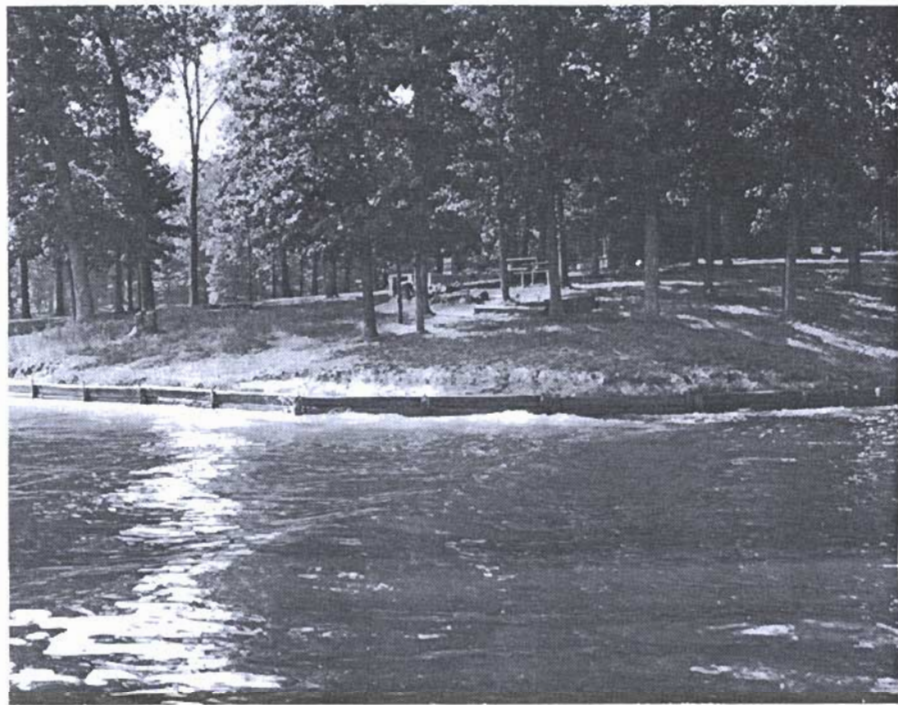
However, the process results in the loss of considerable land, generally high-value promontory land. Usually, land owners try to protect exposed erodable areas with seawalls, such as the low barrier pictured in Figure 2. Unless they are well constructed, they require almost constant upkeep at great expense.

FIGURE 2. Low wood barrier wall.

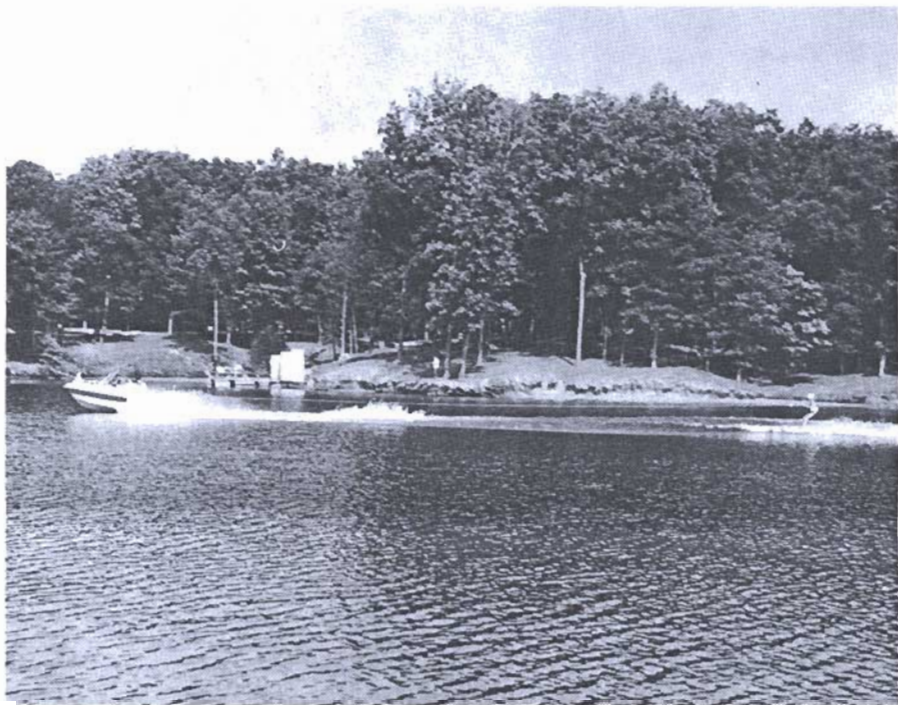
Normal wave action generated by boats cruising 100 yards from shore reaches the shore with a dynamic pressure of less than 5 pounds per square foot. A speeding boat pulling a skier at 20 miles per hour as shown in Figure 3 and at a distance of 20 yards from shore can send shoreward waves that exert pressures on the shore of 500 to 1000 pounds per square foot. Obviously, the answer to this kind of

FIGURE 3. Pleasure boat producing waves.

erosion is the enforcement of stricter rules for boat operation. Since dynamic pressure varies as the cube of the wave height, erosion can be reduced considerably if waves have more distance to travel before they intersect the exposed shore and break with less force.

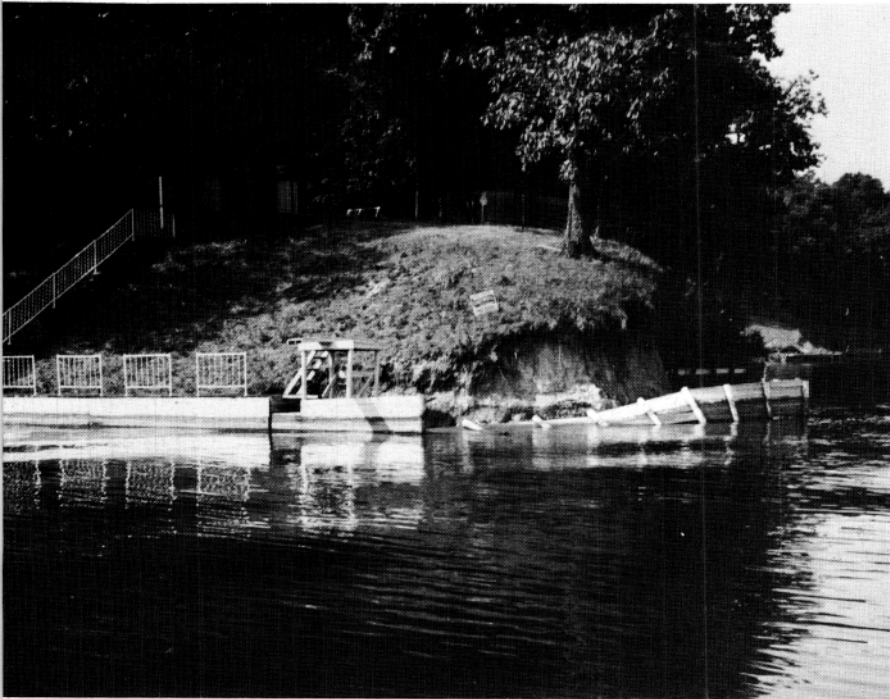
Generally, shore property along Illinois lakes is not provided with protective devices until erosion has progressed considerably. The disturbed owner will then observe the protective devices already installed on other shore properties and will copy them without regard to applicability to a specific situation. Figure 4 is typical of improper planning to curtail bank erosion.

FIGURE 4. Inadequate barrier fails to stop bank erosion.

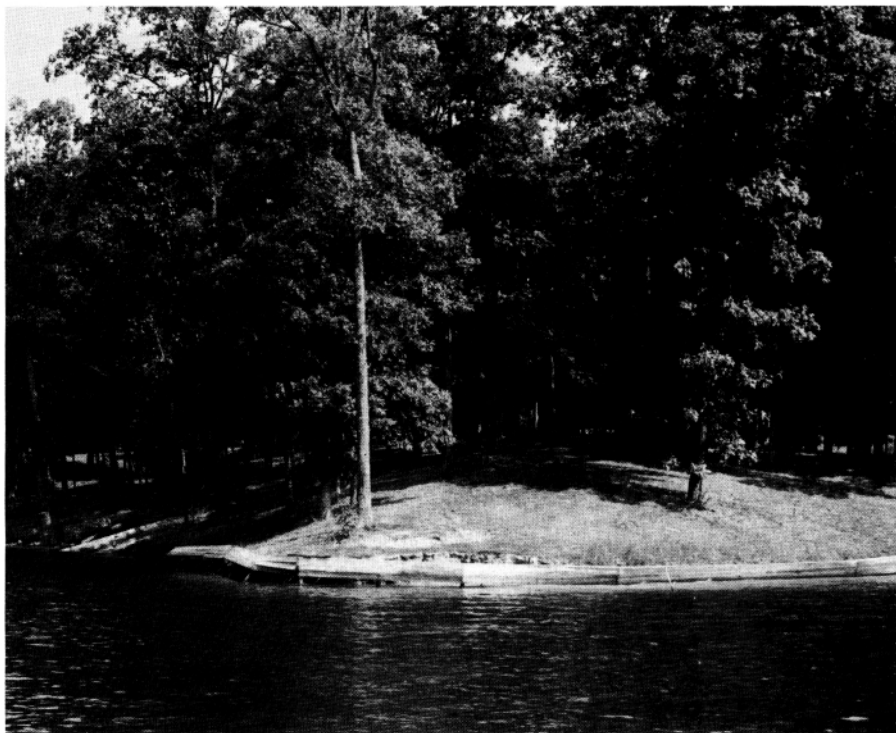
coarse filler material such as bricks, rocks and cement blocks. Most owners have had relatively good experience with this type of construction, but any unusual high water tends to lift the structure out of the water as shown in Figure 5.

FIGURE 5. Wood barrier uprooted by high water.

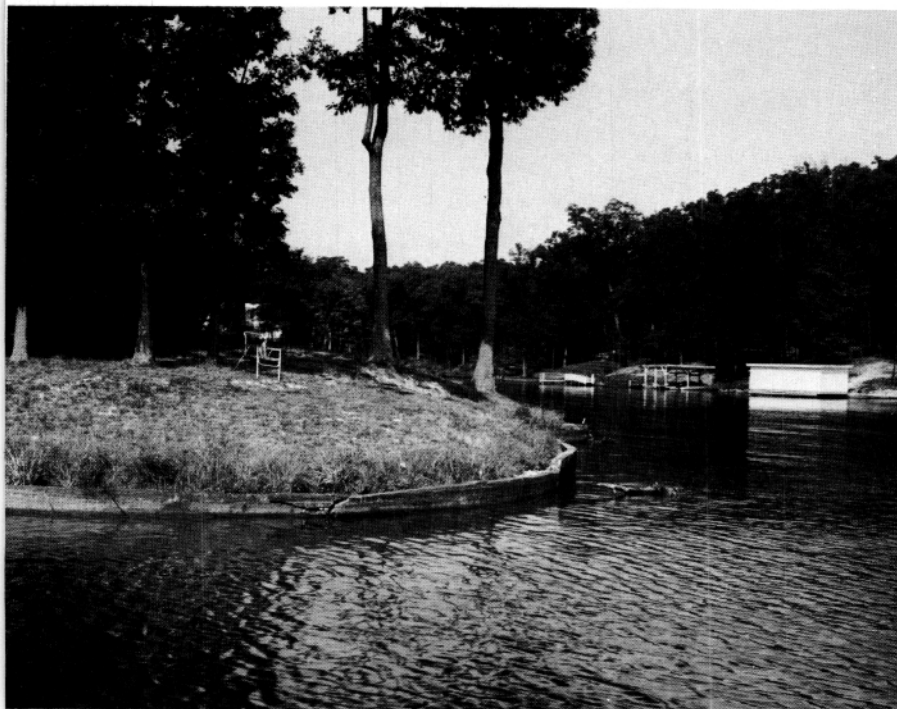
FIGURE 6a. Wall failure where reinforcing rods were omitted.

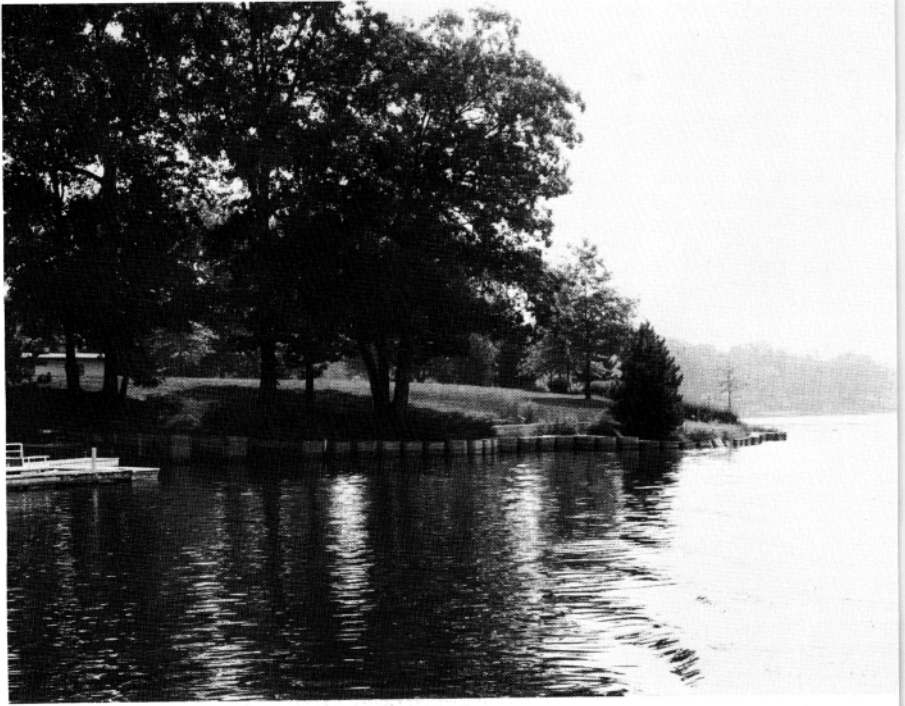
One erosion barrier that has had a fair measure of success consists of a continuous concrete wall approximately 6 inches wide and extending from the ground vertically to a height 6 inches above spillway crest elevation. The wall is strengthened with reinforcing rods and supported on the shore side with rocks, bricks, and broken concrete. Where rods have not been tied together, failure has occurred in the wall at the discontinuity, as shown in Figure 6a. A similar wall may be strengthened at regular intervals with corrugated metal area-way projections 2 feet deep and 3 feet in diameter. They are connected to the main wall with trellis-type wire and filled with concrete. The semicircular shape of the way-walls tends to absorb much of the wave energy. The wall shown in Figure 6b has withstood three years of battering.

FIGURE 6b. Corrugated area-way projections provide strength to erosion barrier.

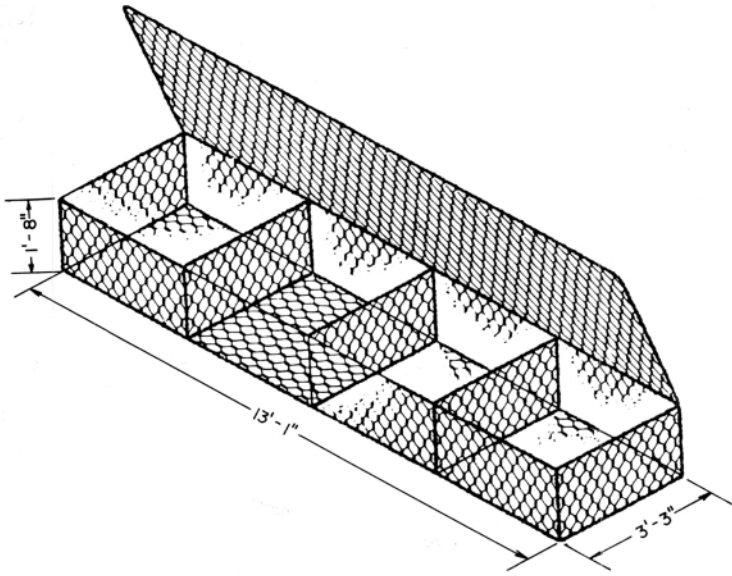
FIGURE 7. Gabion fabricated from heavy steel wire mesh.

One form of protection that should prove beneficial is the gabion. This is a steel wire mesh box made of a complete and continuous fabric, as shown in Figure 7, and filled with stones or rocks. It may be constructed in varying sizes and shapes, although in practice the horizontal width should be at least three feet. The height can be fractions of the width and the length up to four multiples of the width. The wire mesh, having a minimum size of U.S. Steel Wire Gage No. 11, should be galvanized with a minimum zinc coating of 0.80 oz./per square foot of wire surface. The area of the mesh openings should not exceed 8 square inches, and the maximum linear dimension of the opening not exceed 4.5 inches. Strength, elasticity, and flexibility are necessary requirements of gabions so they should be divided into compartments with dia-

phragms of the same mesh and gage as the main body. The smaller cells diminish the internal movement of the rock fill. Single unit construction is necessary so that edges of the base, lid, ends, and sides have the same strength and flexibility as the body of mesh.

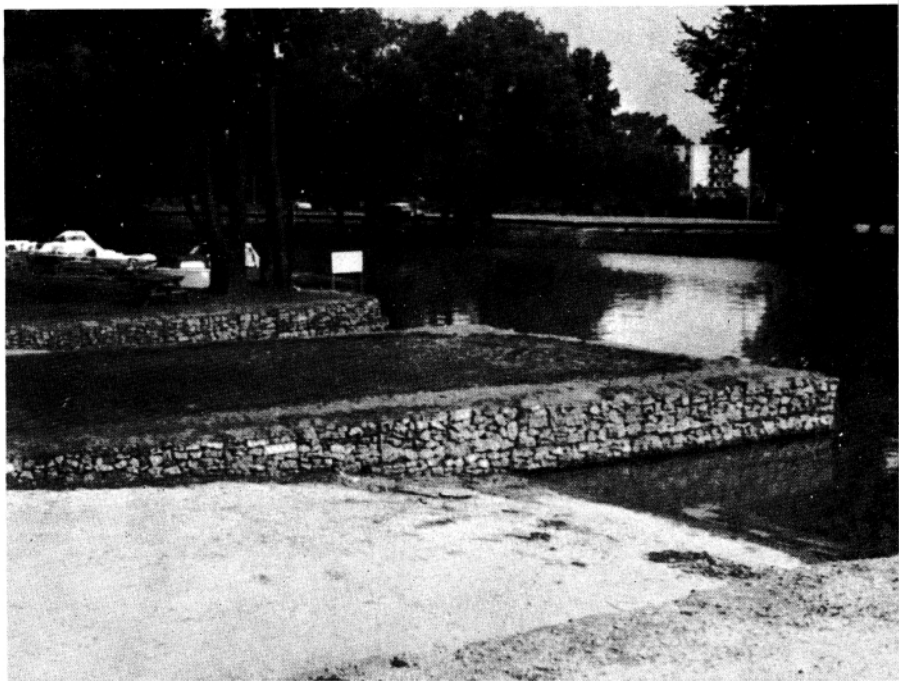
FIGURE 8. This gabion wall protects lake-front property.

Contractors have installed gabion walls at a cost of \$69 per running foot. Figure 8 shows a typical gabion wall. A sheet steel type of wall driven to a depth of ten feet costs about \$1800 per lineal foot. While this is the best protection, especially where salt water and wave action is great, the gabion has attributes that make it preferable for preventing shore erosion at small lakes. The rock-filled walls are porous and therefore not as subject to hydrostatic pressure deformations, especially concrete ones. As they fill with silt they support plant life and blend in

with the natural surroundings. The gabion type of structure protects the headland or "toe" of the shoreline from undermining, which causes most bank failures due to wave action.
