Engineering Aspects of the Geology of the Vienna City Reservoir*

George E. Ekblaw

State Geological Survey, Urbana, Illinois

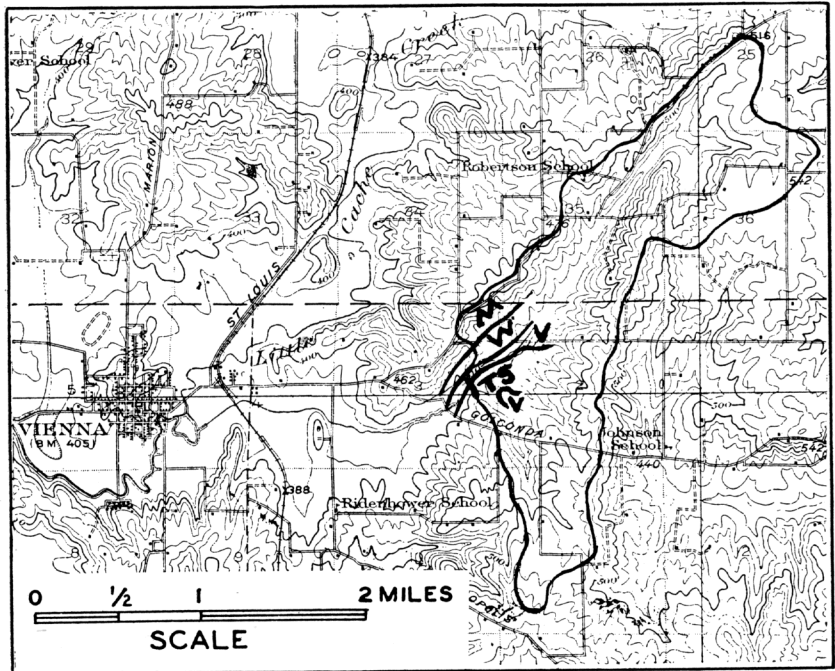
Fig. 1.—Part of Vienna quadrangle topographic map, showing location of dam for Vienna city reservoir, the limits of the contributing watershed, and areal distribution of bedrock at damsite. **M** = Menard limestone, **W** = Waltersburg sandstone, **V** = Vienna limestone and shales, **TS** = Tar Springs sandstone.
